**Vehicular Crash Tests Of  
Unanchored Safety-Shaped  
Precast Concrete Median Barriers  
With Pinned End Connections**

**FINAL REPORT**

**CA-DOT-TL-6824-1-76-52**

**AUGUST 1976**

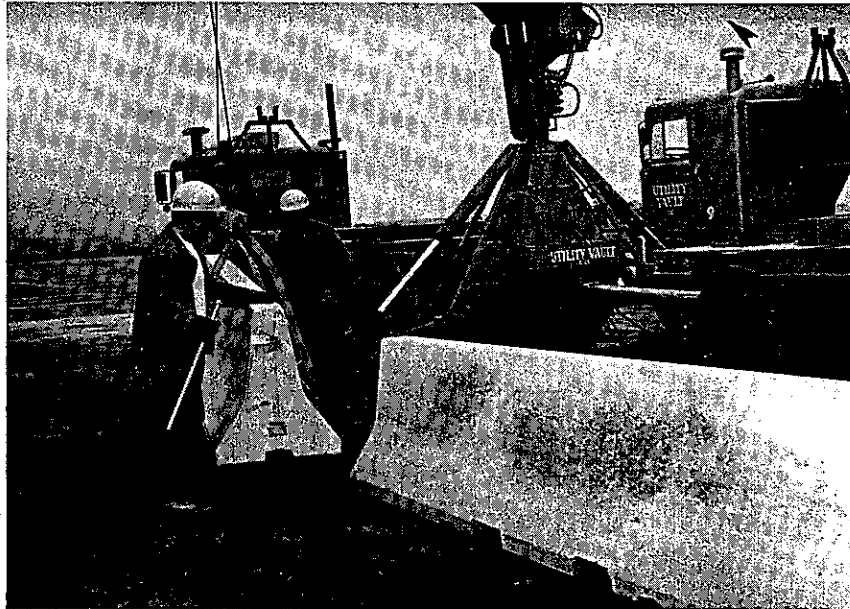
Figure 1, Placing 12.5 Foot Barrier Segments  
With Truck Crane

Barrier segments for Tests 291 and 292 were delivered to the test site by truck and placed in position by a small crane which was mounted on the rear of the delivery truck. The crane operator, standing on the ground, used remote controls to position each 12.5 foot long barrier segment, Figure 1. Two large tongs, hooked in small slots next to the scuppers, held the barrier segments during the placement operation. This method of placement was quick and easy.

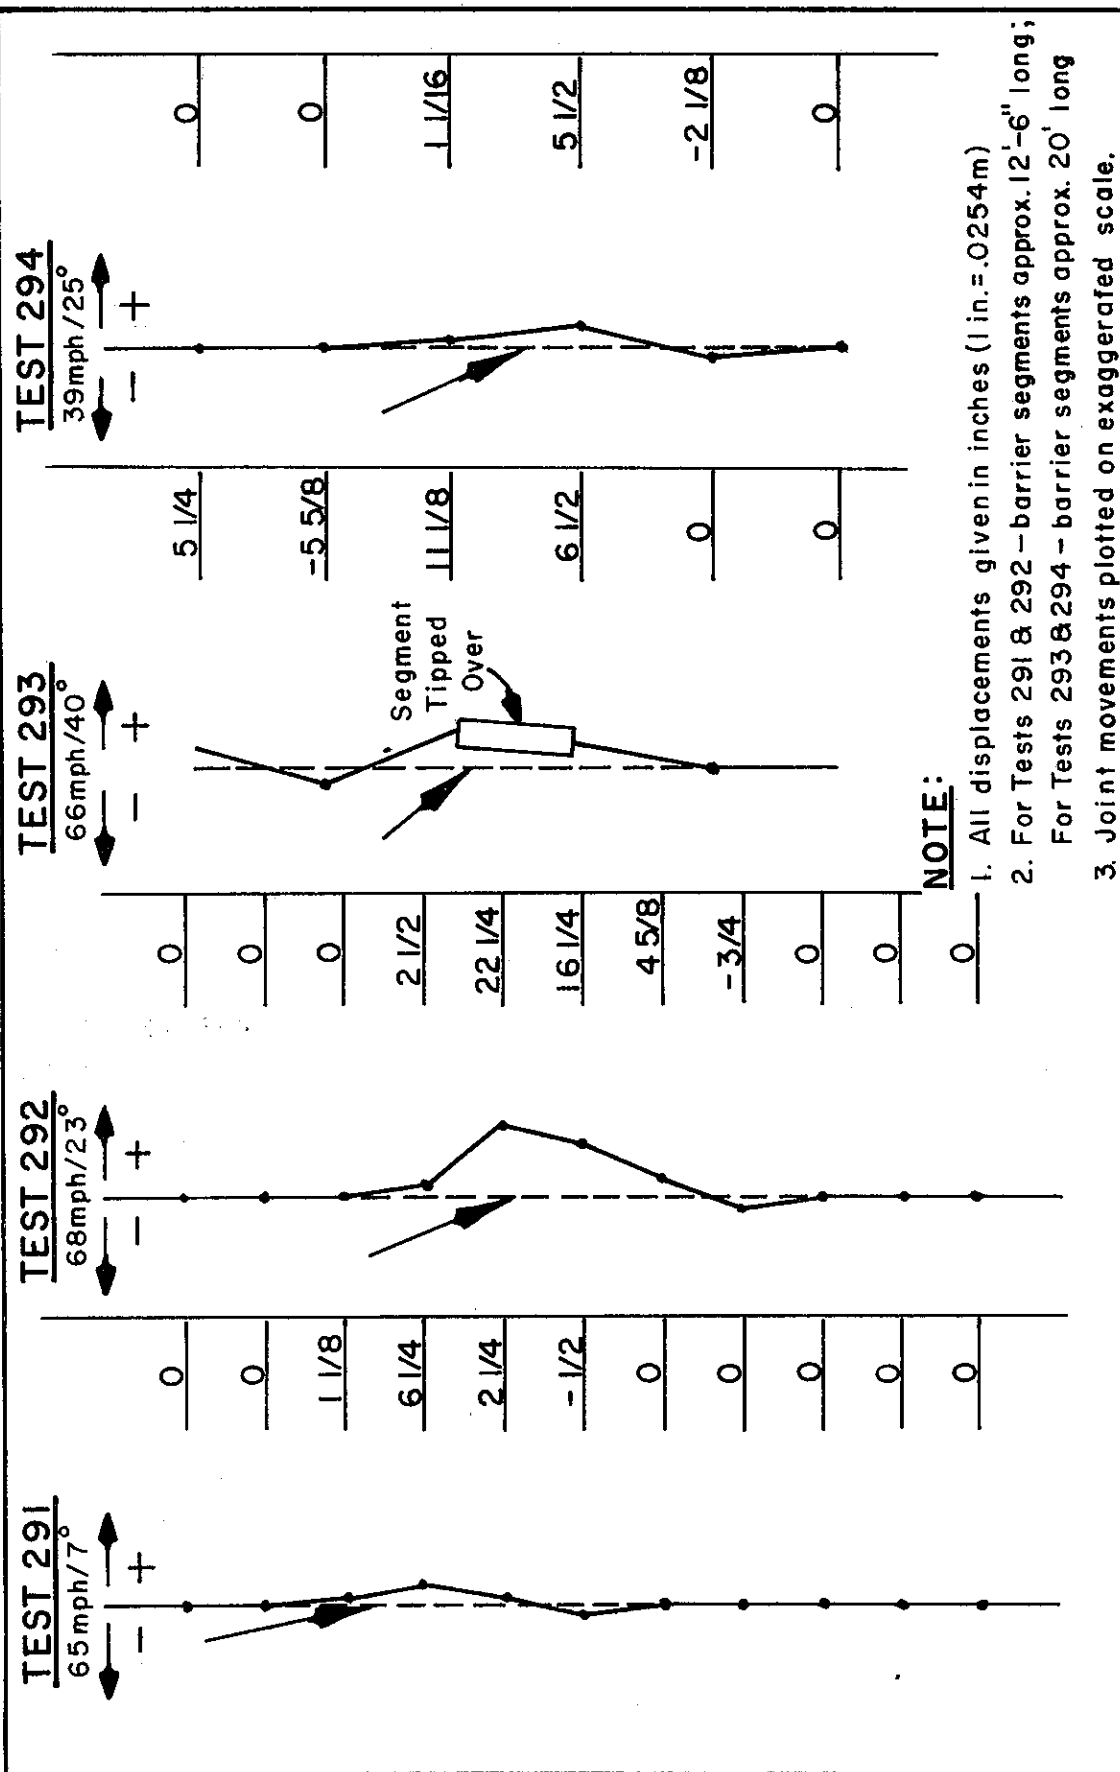
Figure 7

Barrier Movement and Damage - Four of five barrier segments were laterally displaced during impact, Figures 7 and 9. Only the last barrier segment remained on line. Maximum lateral displacement of  $11 \frac{1}{8}$  inches occurred at the upstream joint of the first impacted barrier segment, joint 2, Figure 7. The second and third joints failed to restrain the lateral and rotational movement of the impacted barrier segment, which tipped over on its side. The steel hinge bars and steel connecting rods were severely bent, Figure 16. The steel rod at joint 1 was also bent during impact, Figure 17.

Barrier Movement and Damage - Four of six barrier segments were laterally displaced during impact, Figures 7 and 9. Maximum lateral displacement of 5 1/2 inches occurred at the first barrier joint downstream from impact.

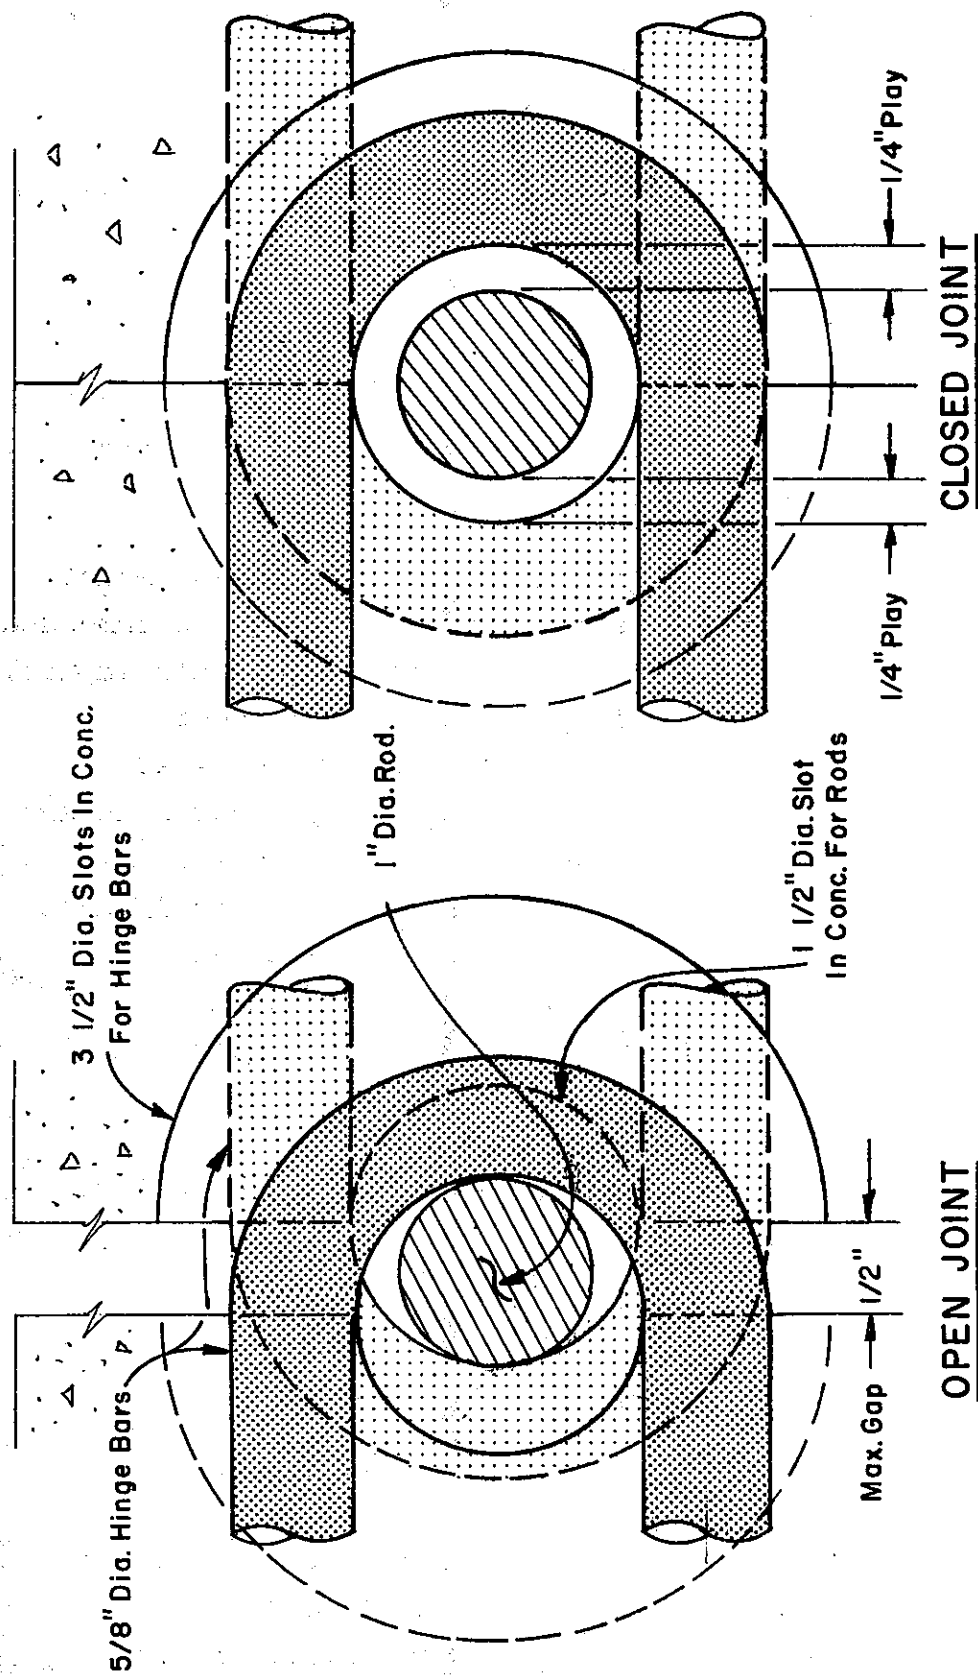
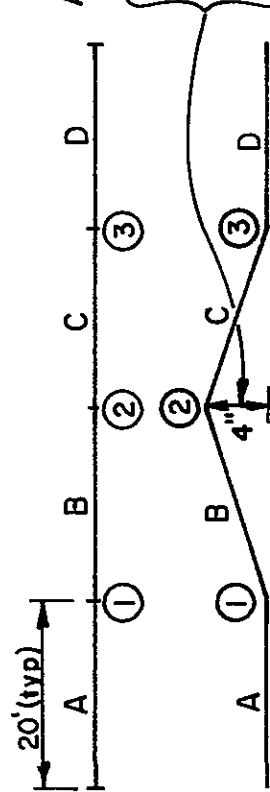
Figure 27, Test 294, Pinned Joint Connection

Summary. The amount of joint flexibility and the ability of the joints to transmit impact loads to adjoining segments is illustrated by the following example and Figure 27. In the barrier design for Test 294, there is a maximum amount of horizontal "play" or looseness between rods and hinge bars of 1/2 inch, i.e., if two adjoining segments are stretched out in opposite directions to the

maximum extent, the gap between segments will be 1/2 inch wide, Figure 27 open joint. If the segment ends are initially butted together, then there is a potential amount of "play" of 1/2 inch at each joint, Figure 27 closed joint. If two adjoining segments are deflected laterally until the 1/2 inch "play" is used up at the three end joints, then the maximum lateral deflection of the joint between the two segments will be about 4 inches, assuming 20 foot segment lengths with no movement of the segments adjoining the two which were deflected and no barrier damage.

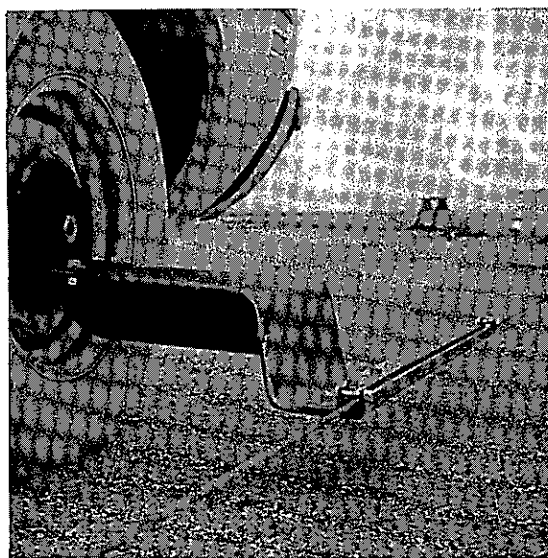
Figure 1A, Cable Guidance Bracket

Test Conditions - A 1969 Dodge Polara sedan weighing 4860 lbs impacted the precast concrete test barrier at  $40^\circ$  with a velocity of 66 mph. A malfunction of the cable guidance bracket causing vehicle yawing prior to impact, prevented the vehicle from attaining an anticipated impact angle of  $25^\circ$ . The third 20 foot long segment of the 100 foot test barrier was impacted 1 foot beyond its upstream end, Figure 7.

anchored at each end of the vehicle path, passed through a slip-base guide bracket, Figure 1A, bolted to the spindle of one of the vehicle's front wheels. A steel angle post driven into the ground near the barrier projected high enough to knock off the guide bracket thereby releasing the vehicle from the guidance cable prior to impact.

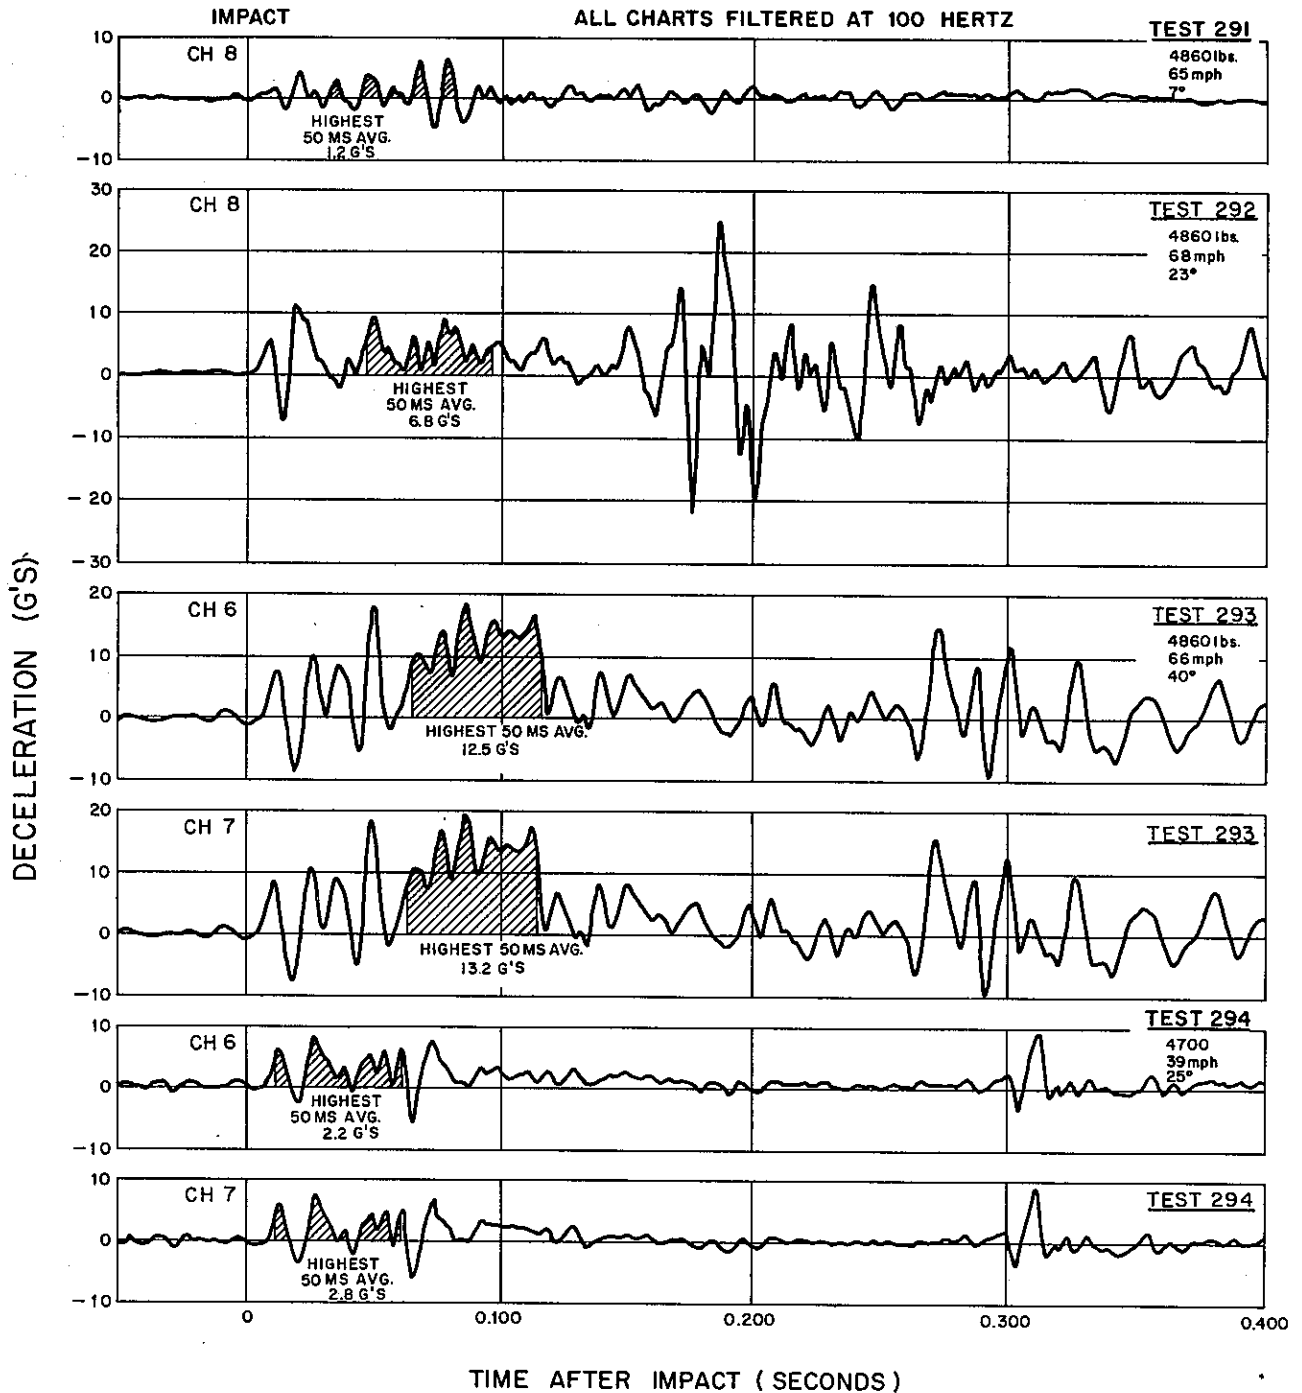
Longitudinal and lateral vehicle deceleration records for each test are shown in Figures 6A and 7A. Deceleration responses of the anthropometric dummy and the lap belt record for each test are shown in Figures 8A through 12A.

Figure 7A, VEHICLE DECELERATION VS TIMELATERALUNANCHORED PRECAST SAFETY  
SHAPED CONCRETE BARRIERS

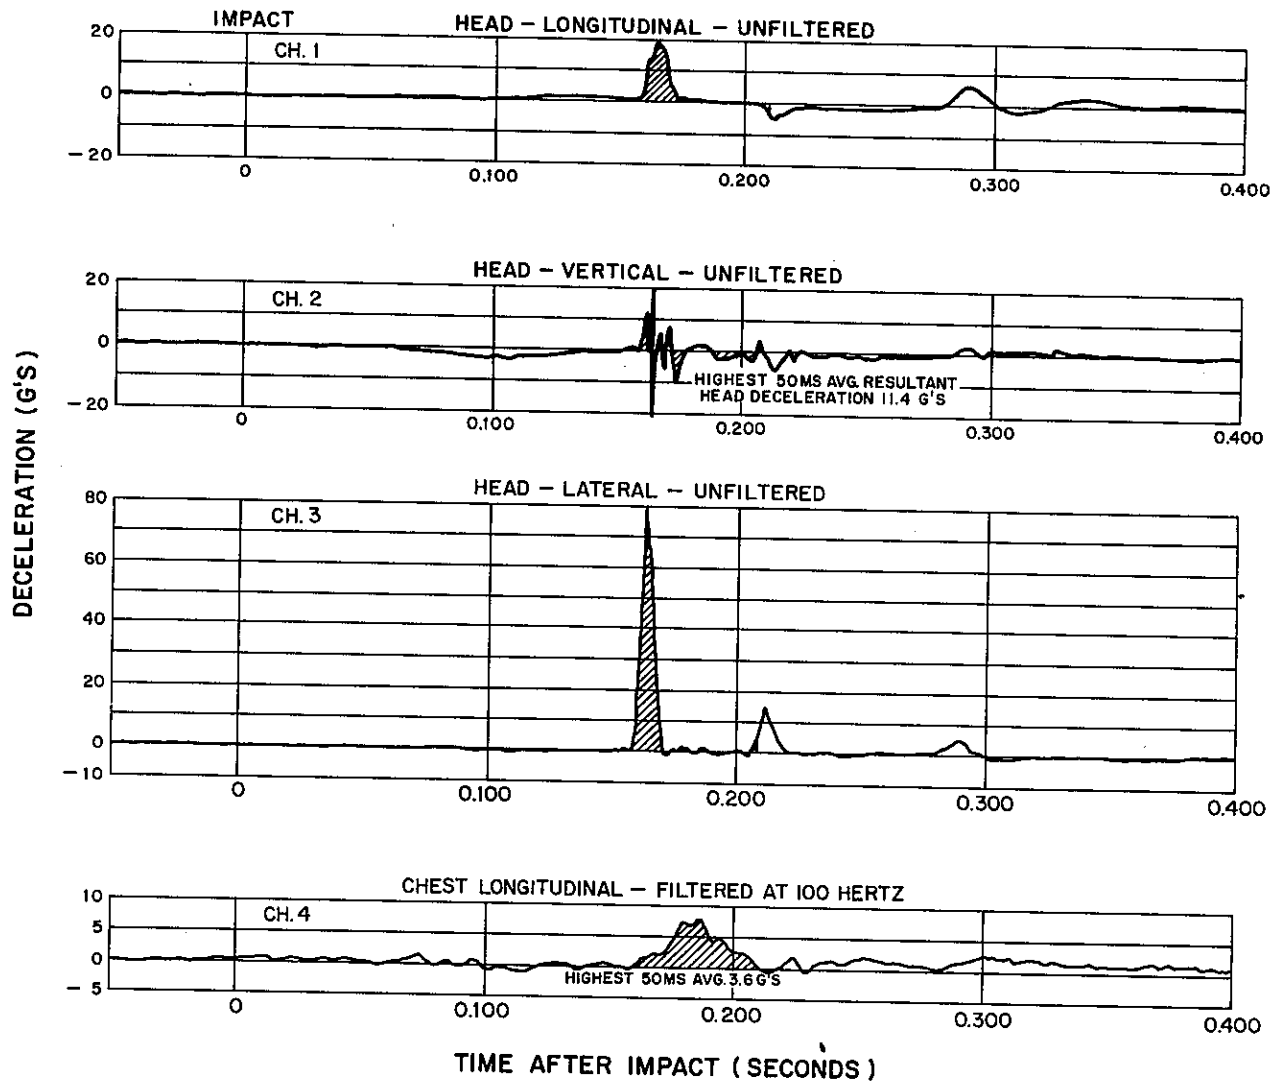
Dummy Behavior - Due to a camera malfunction, high speed film coverage of the lap belted dummy was not available for analysis. However, dummy accelerometer and lap belt load data are included in the Appendix, Figures 9A and 12A.

**Figure 9A, DUMMY DECELERATION VS TIME**  
**TEST 292, 48601b. VEHICLE, 68 MPH, 23° LAP BELT**  
**12.5 FT. LONG SEGMENTS, NO DESIGN GAP AT PINNED JOINTS**  
**UNANCHORED PRECAST SAFETY SHAPED CONCRETE BARRIER**

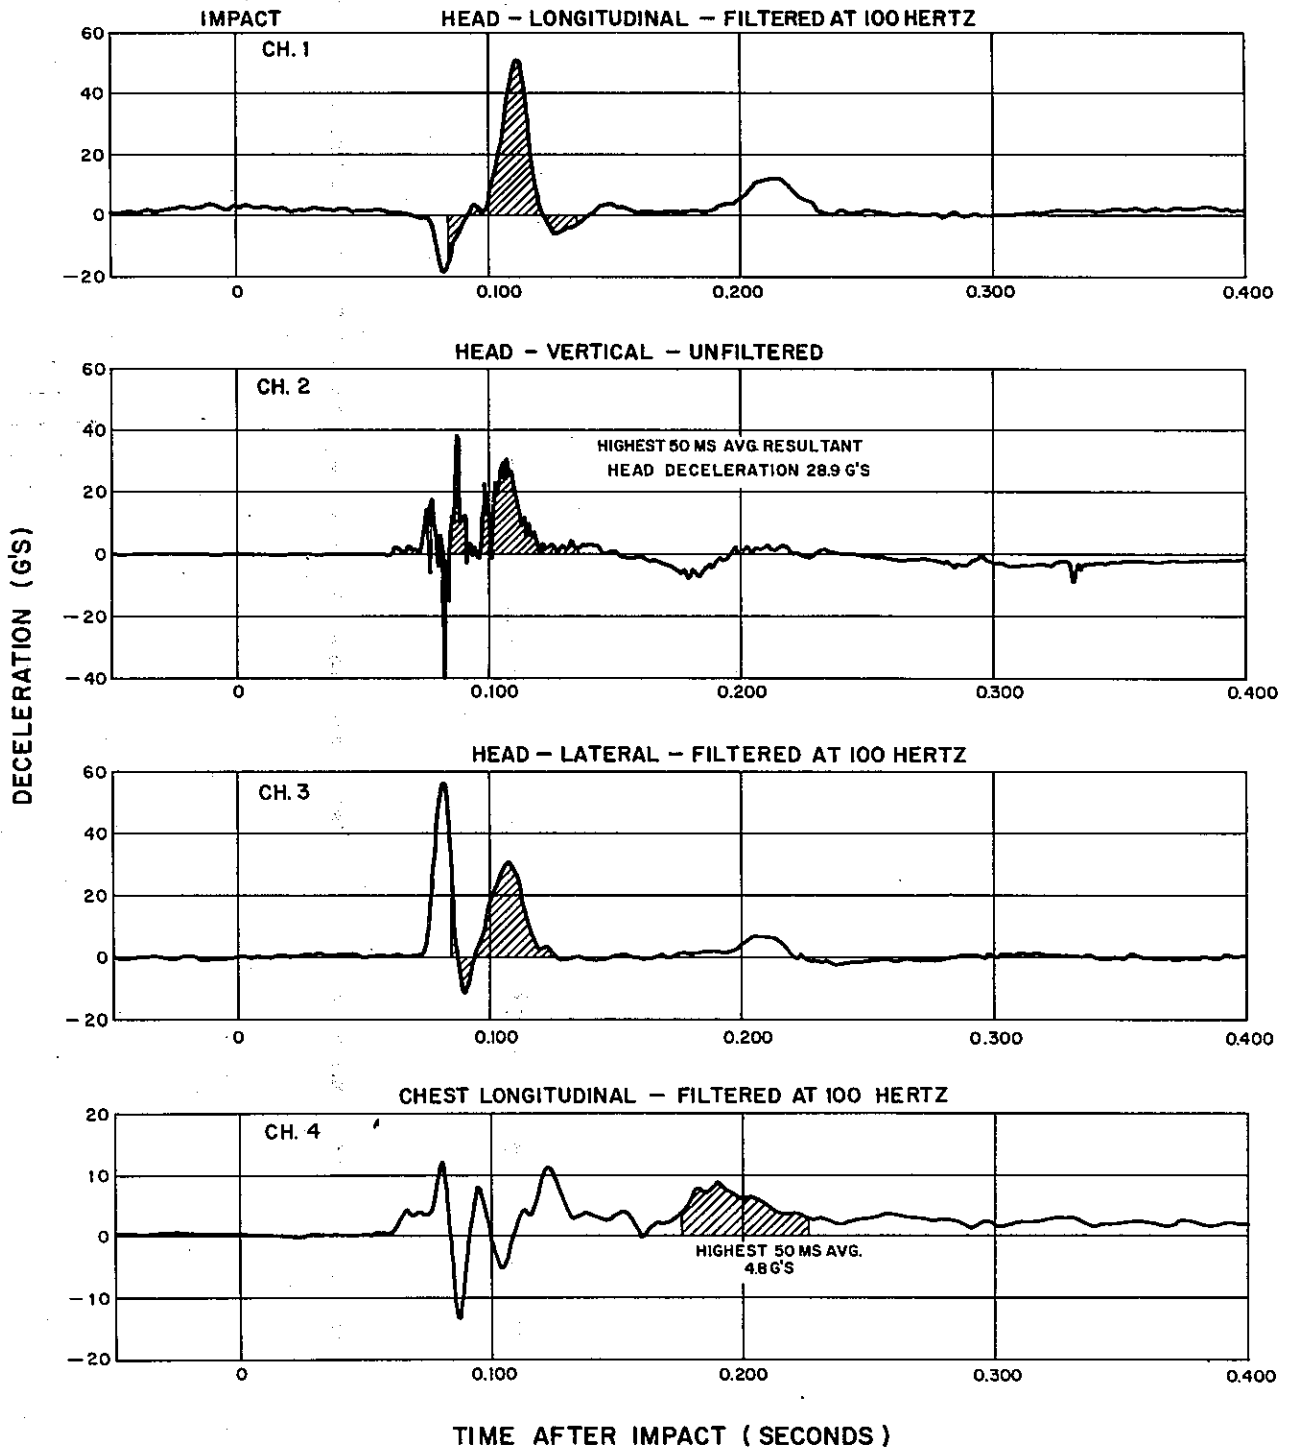
Dummy Behavior - Upon impact, the dummy, restrained by a lap belt, slumped towards the passenger's side and moved forward under the dashboard of the vehicle. As the vehicle descended from its airborne trajectory and hit the ground, the dummy impacted the steering wheel and the left front wing window. As the vehicle rolled over, the dummy's head protruded out the front door window and impacted the ground. When the top of the vehicle caved in during the vehicle rollover, the dummy's right arm and shoulder were crushed. After impact, the dummy was found slumped against the left door. Dummy accelerometer and lap belt load data are included in the Appendix, Figures 10A and 12A.

**Figure 10A, DUMMY DECELERATION VS TIME**  
**TEST 293, 4860lb. VEHICLE, 66MPH, 40°, LAP BELT**  
**20 FT. LONG SEGMENTS, DESIGN GAP AT PINNED JOINTS=2.75IN.**  
**UNANCHORED PRECAST SAFETY SHAPED CONCRETE BARRIER**

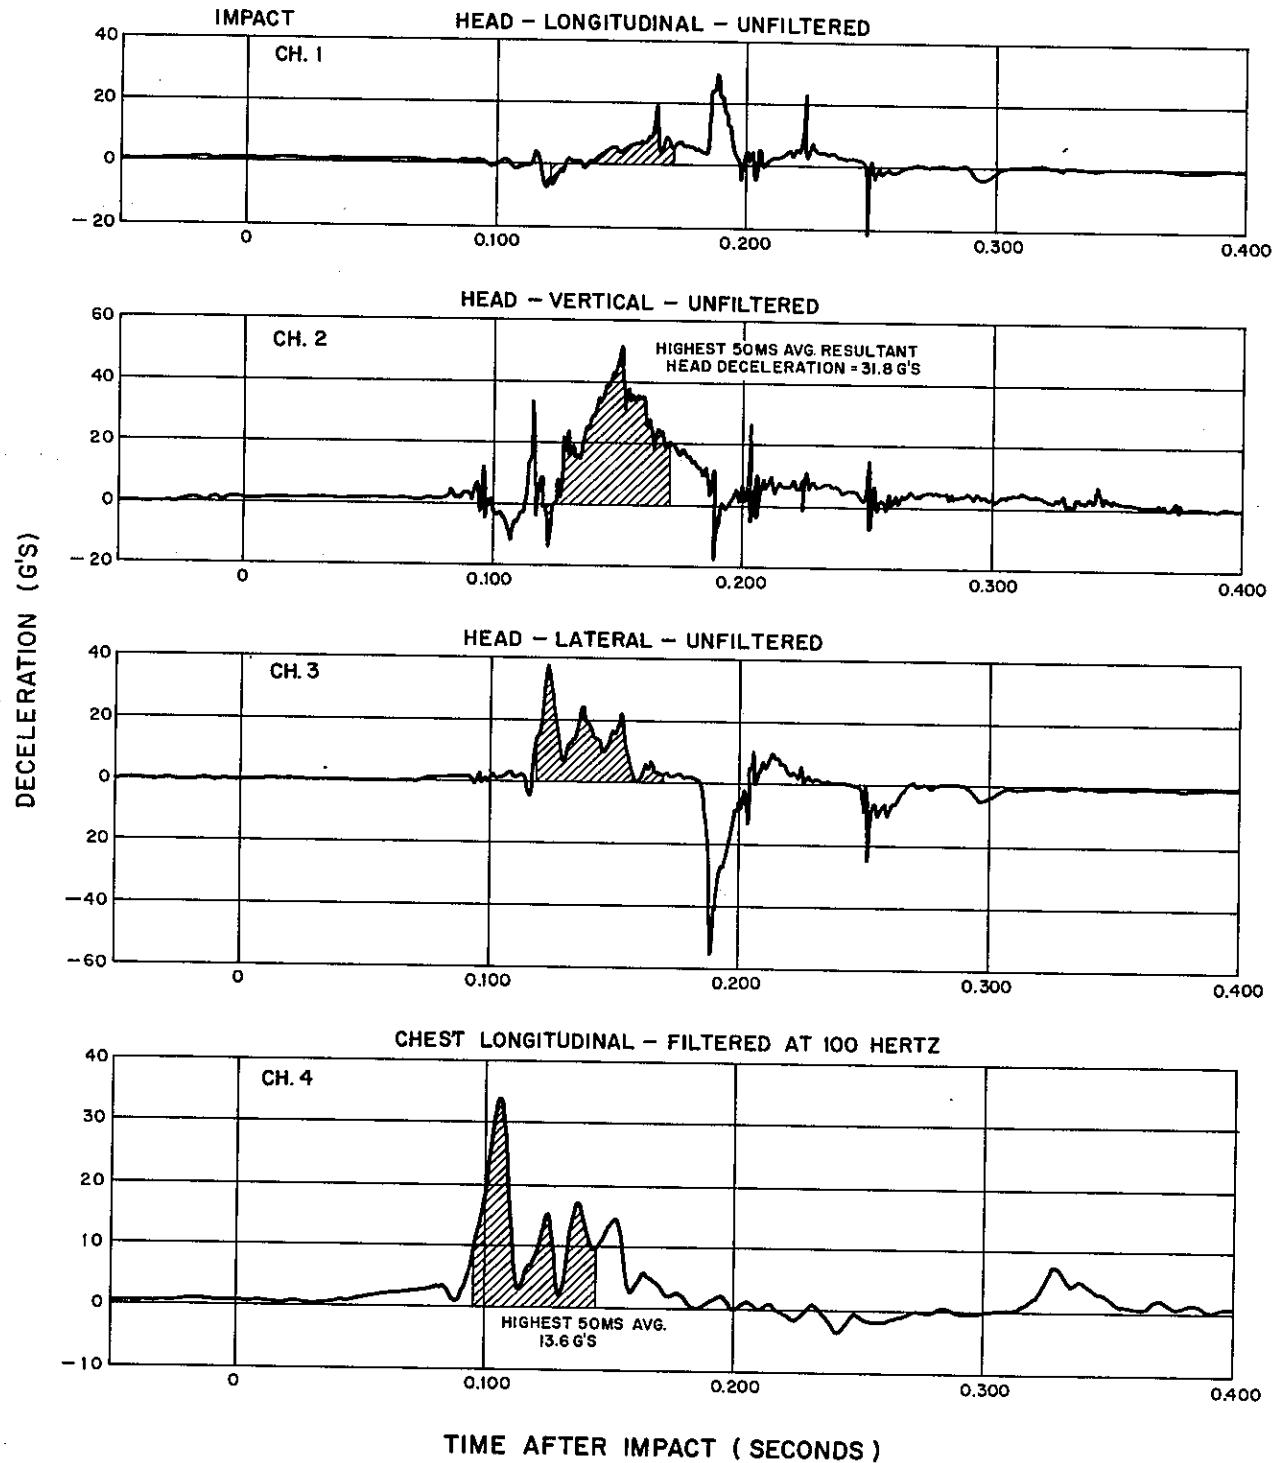
Figure IIA, DUMMY DECELERATION VS TIME  
TEST 294, 4700lb. VEHICLE, 39 MPH, 25° LAP BELT  
20 FT. LONG SEGMENTS, NO DESIGN GAP AT PINNED JOINTS  
UNANCHORED PRECAST SAFETY SHAPED CONCRETE BARRIER
